# Runway 5-23 Rehabilitation Project

# RWY 5-23 Rehabilitation Project

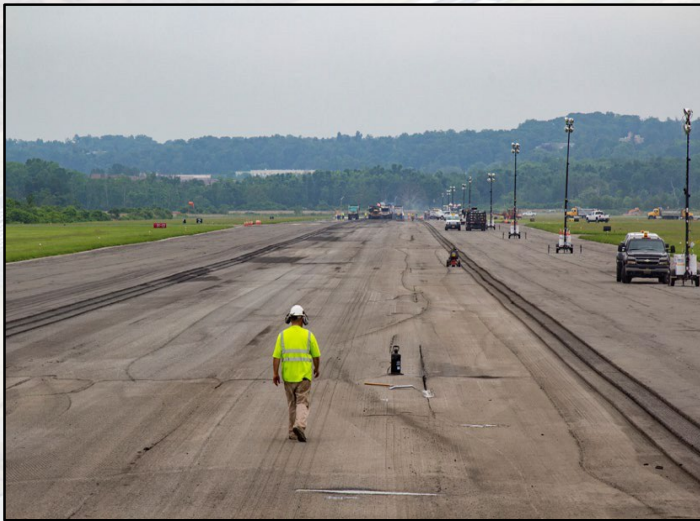
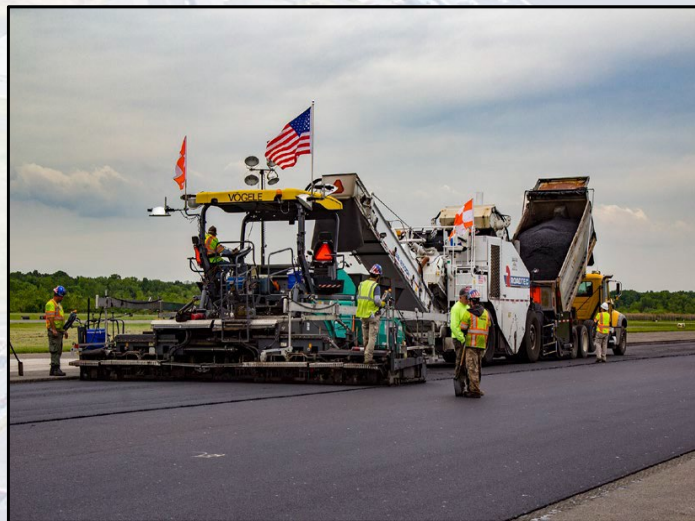
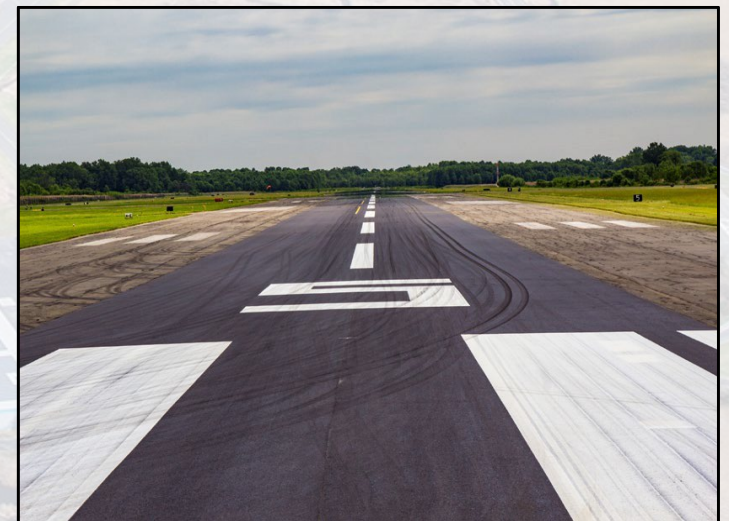
- Milled out and repaved center 50' Keel Section of 5,800' of RWY 5-23
- Addressed depression on RWY 5-23 to provide pilots with a better operational surface

**2015 – 2017:** New Keel section provided the proper structural integrity for future phases.

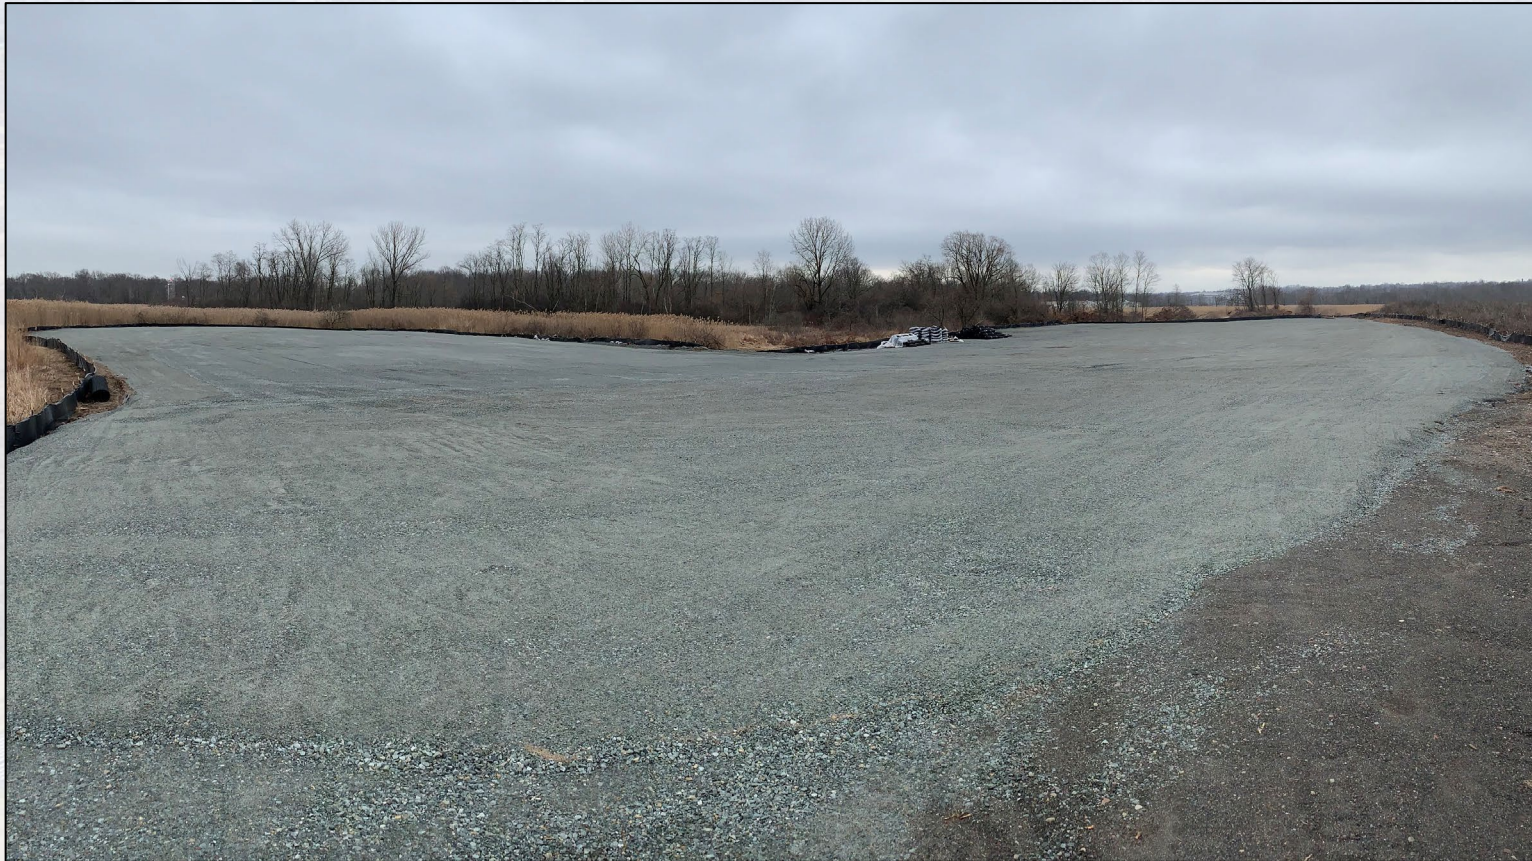
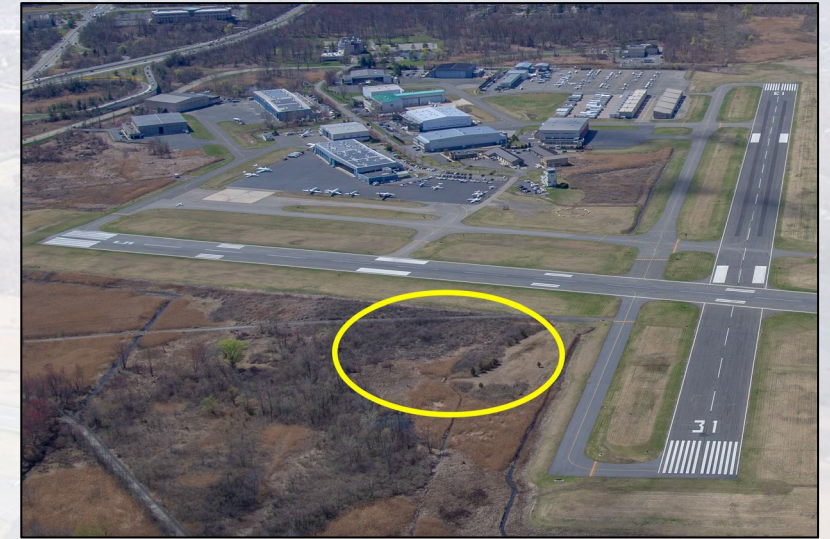
# Construction Staging Area (Completed in January 2020 as part of [Phase VI](#))

The staging area for all construction vehicle access during the RWY 5-23 Rehabilitation Project was completed in January 2020.

This area provides airport access via Columbia Turnpike, minimizing vehicle traffic operating on airfield.

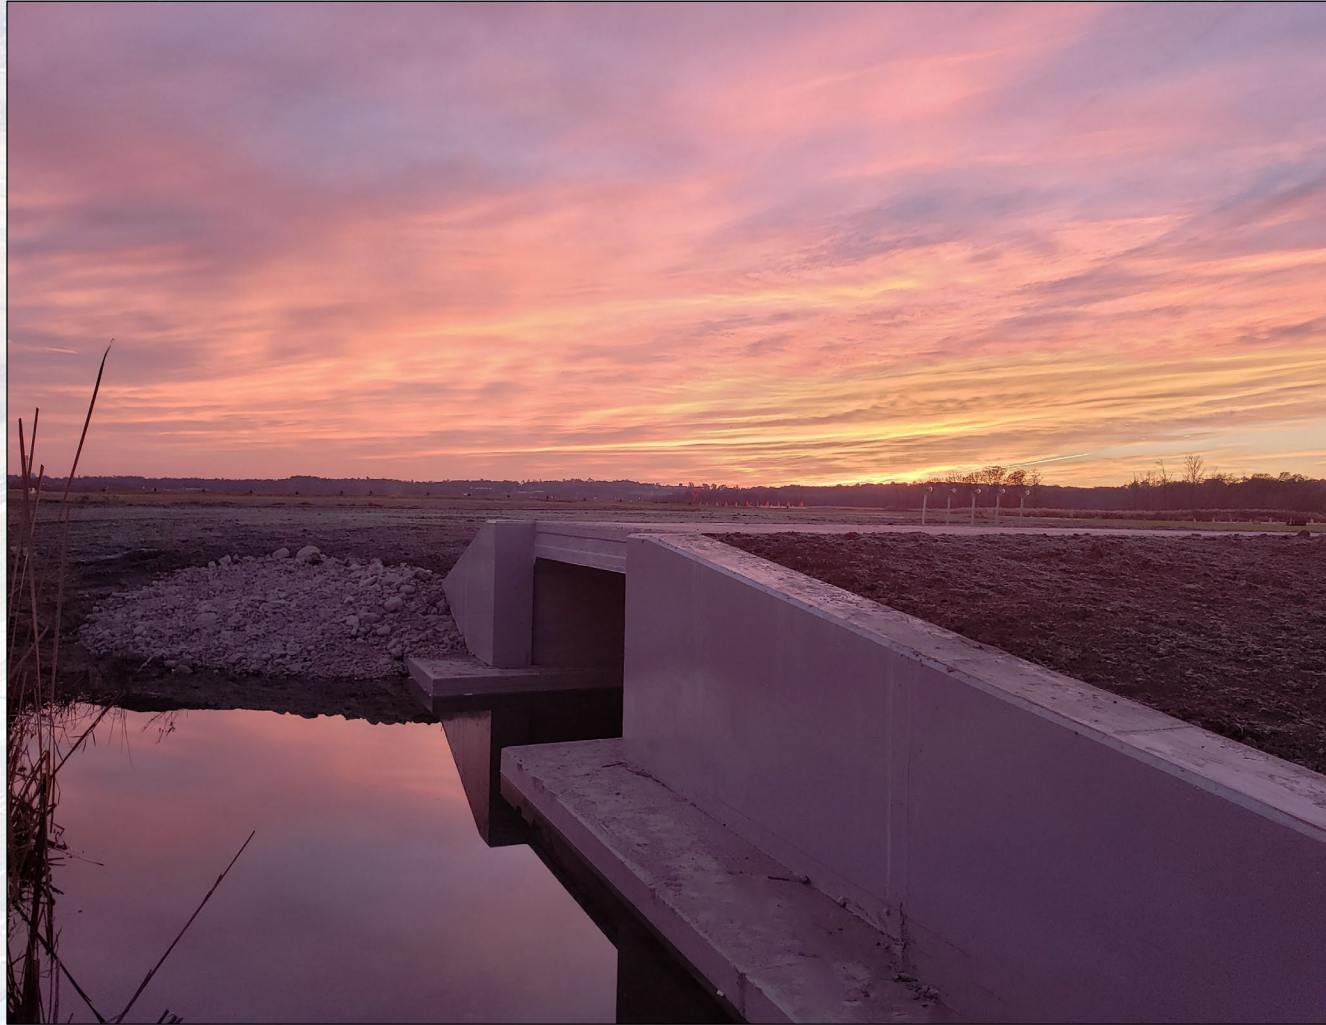
- ✈ Significantly improved RSA by establishing weight-bearing structures under MALSR road for the first 1,000'

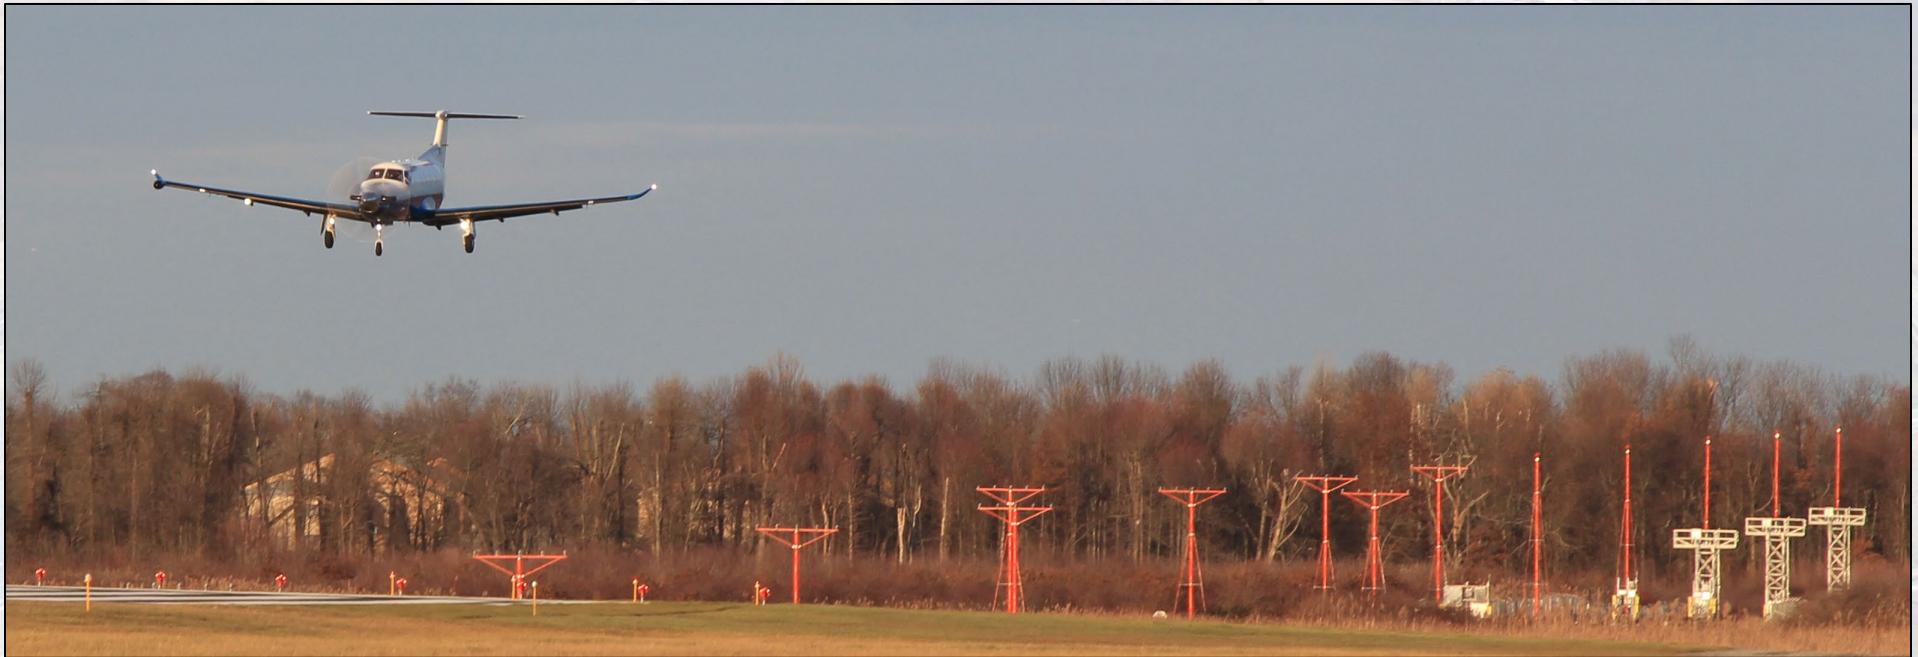
Current MALSR system was outdated and needed to be upgraded. New MALSR System installed on a rising plane and provides greater visibility during IFR conditions.

Grading work provides enhanced Runway Safety Area when departing RWY 5

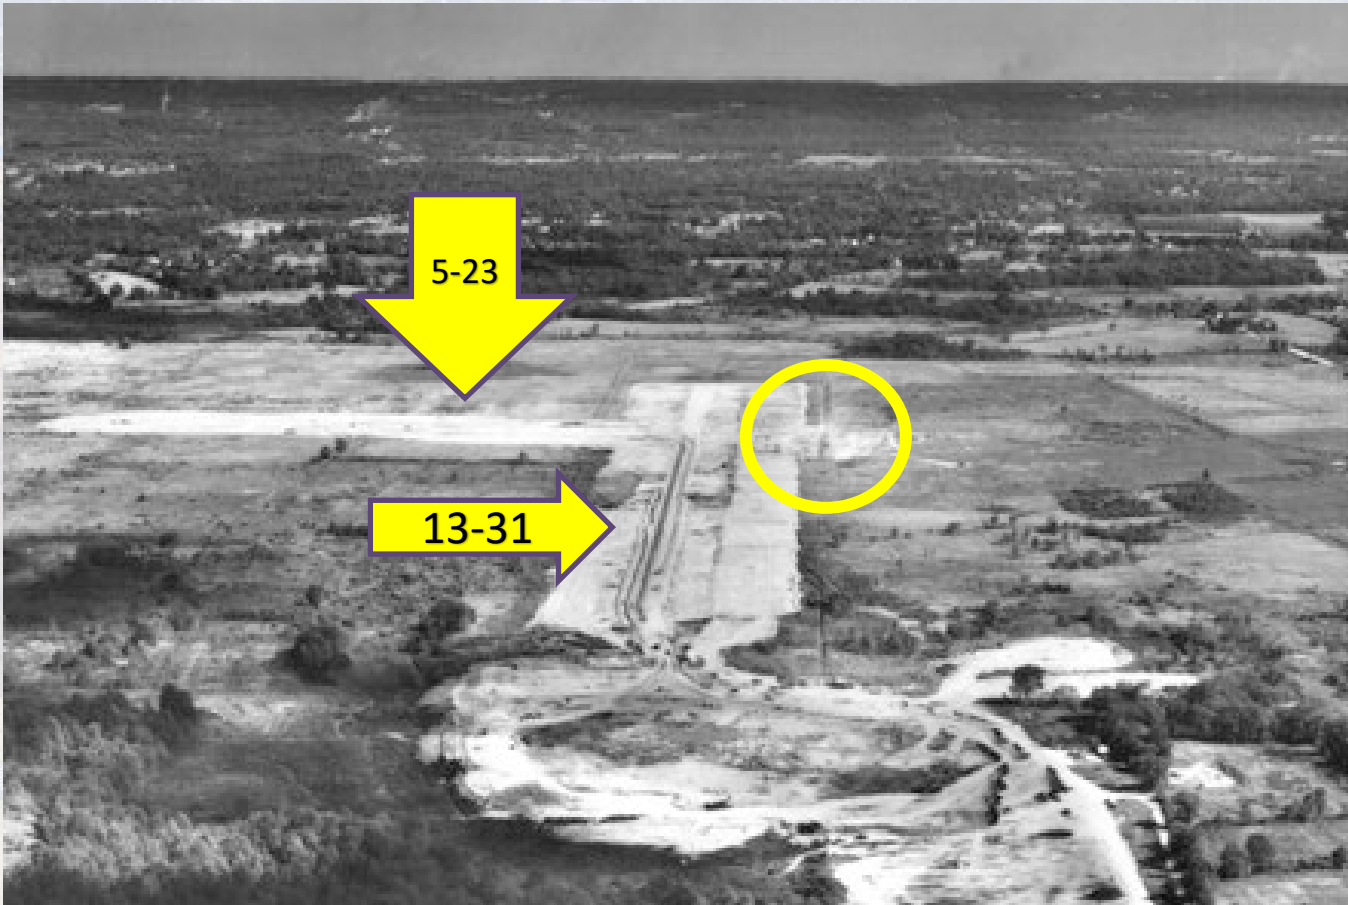
As part of the original development of Morristown Airport, a 36-inch drainage pipe was installed in order to allow water flow underneath Runway 5-23.

There are no records to indicate that this original drainage pipe has ever been replaced and was undersized from the start given the amount of water that has historically flowed on a seasonal basis from the West side of the airport towards the East.

Phase IX will replace the 36-inch drainage pipe with a 56"x72" concrete box culvert, like the culverts installed in 2021 shown on the previous slide.

The new box culvert will appropriately accommodate the expected flow of seasonal water and will mitigate flooding on the West side of the airport.

**Phase IX** of our Runway 5-23 Rehabilitation Project focuses on replacing the original drainage culvert that runs parallel to Taxiway Bravo and crosses underneath Taxiway Alpha and Runway 5-23 (Culvert replacement orange & blue area in left image).
