Runway 5-23 Rehabilitation Project

RWY 5-23 Rehabilitation Project

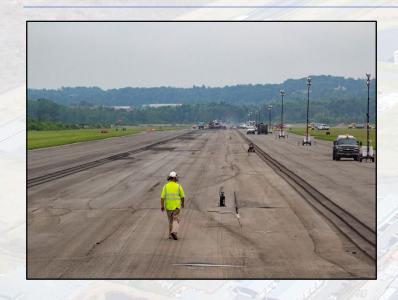
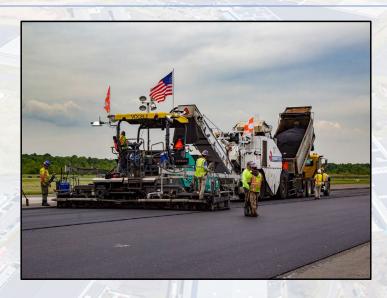
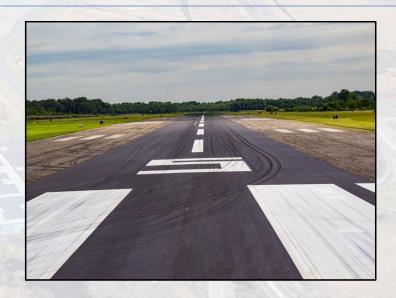
- Milled out and repaved center 50' Keel Section of 5,800' of RWY 5-23
- Addressed depression on RWY 5-23 to provide pilots with a better operational surface

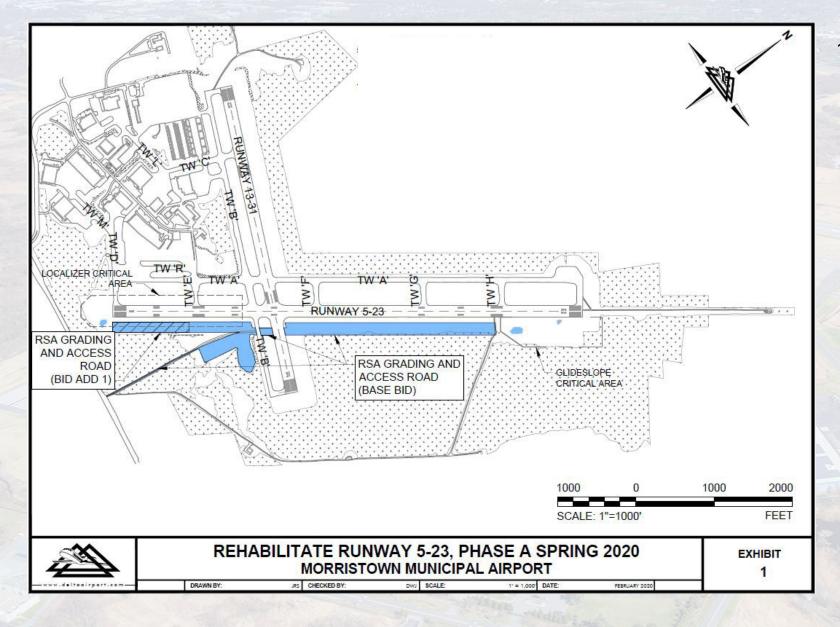
Phase VI: Completed

- ★ Construction Staging area built
 - ★ Completed in January 2020
- ★ Construction of access road along east side of RWY 23
- ★ Grading in Runway Safety Areas

- ★ Access road necessary for equipment to efficiently move to and from the RSA and ultimately to access the approach end of RWY 23 construction areas
- ★ Grading of RSA enhances proper drainage away from RWY 5-23 providing a stable surface that does not retain water
- ★ Grading of RSA reduces chance of aircraft damage when deviation from RWY occurs

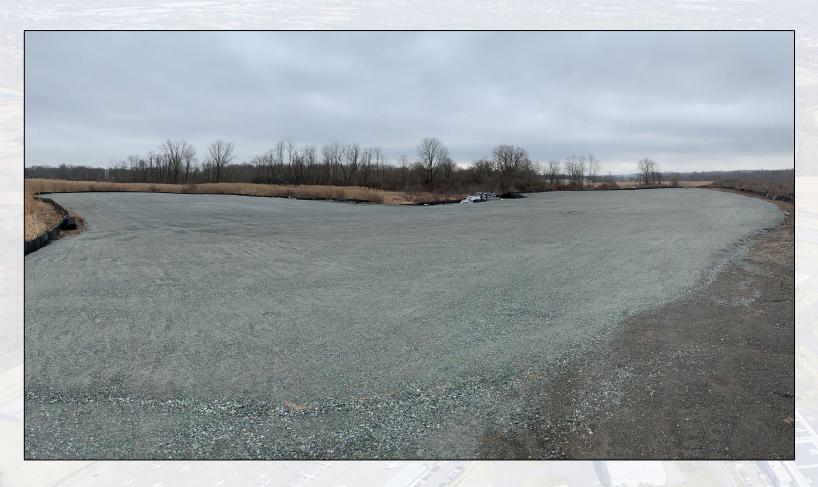
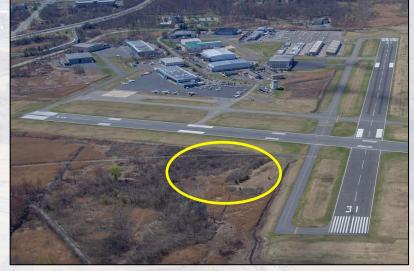
Construction Staging Area (Completed in January 2020 as part of Phase VI)

The staging area for all construction vehicle access during the RWY 5-23 Rehabilitation Project was completed in January 2020.

This area provides airport access via Columbia Turnpike, minimizing vehicle traffic operating on airfield.

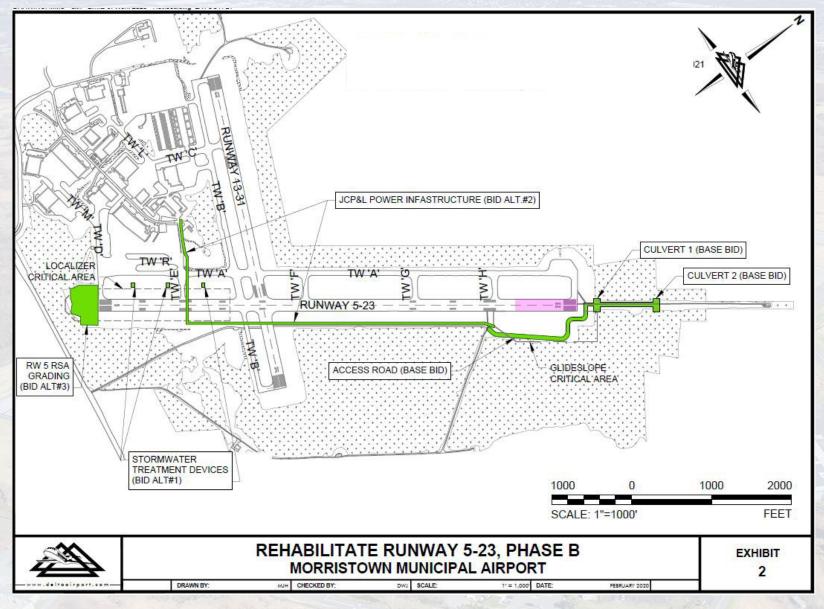
Phase VII: Completed Fall 2021

- ★ Phase VII Work Summary:
 - ★ Relocated threshold was installed on RWY 23 approach end for culvert replacement on MALSR road
 - * RWY 5-23 back to full length as of Nov. 7, 2021
 - ★ Completion of additional perimeter road

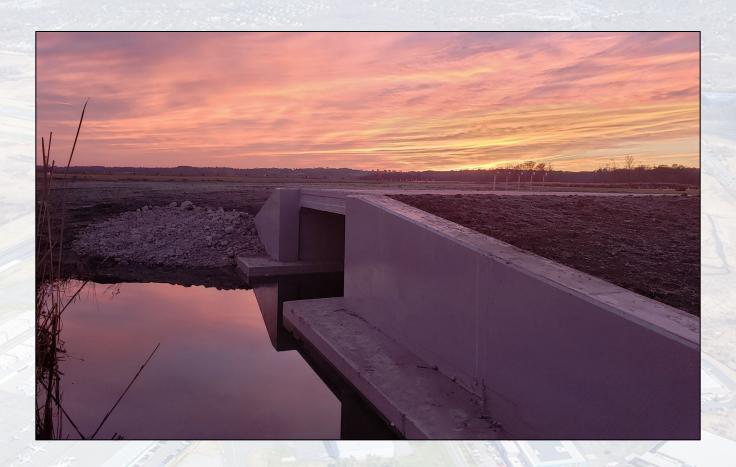
★ Significantly improved RSA by establishing weight-bearing structures under MALSR road for the first 1,000'

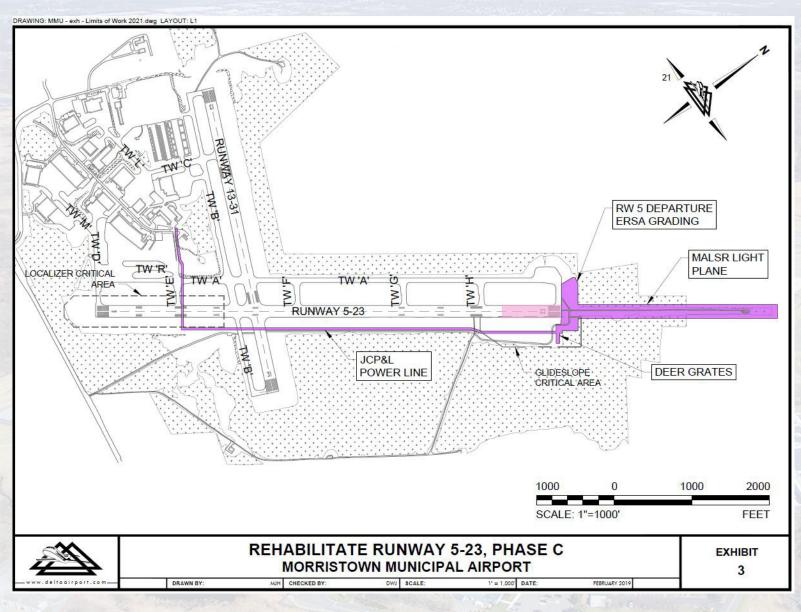
Phase VIII* Completed December 2022

- ★ Phase VIII Summary:
- ★ Relocated RWY 23 Threshold to allow:
 - Regrading of Runway End Safety Area
 - - ★ Upgraded to rising lighting plane
 - ★ Installation of JCP&L Power Line
 - ★ If not completed in earlier phase
 - ★ Replacement of deer grates

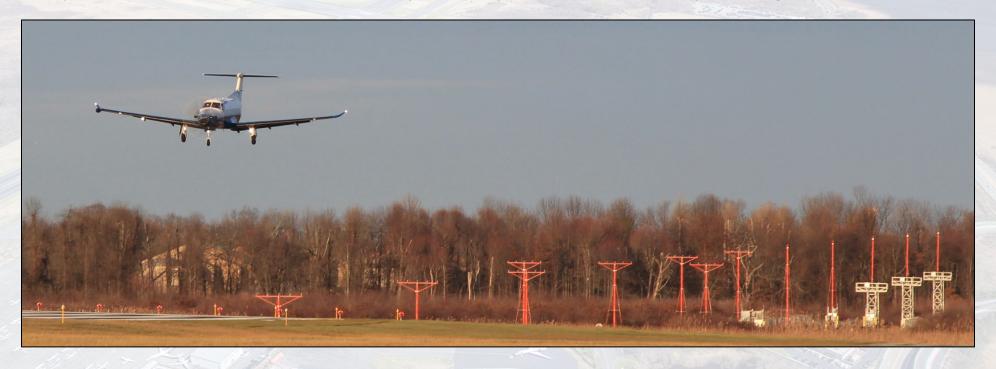
Current MALSR system was outdated and needed to be upgraded. New MALSR System installed on a rising plane and provides greater visibility during IFR conditions.

Grading work provides enhanced Runway Safety Area when departing RWY 5

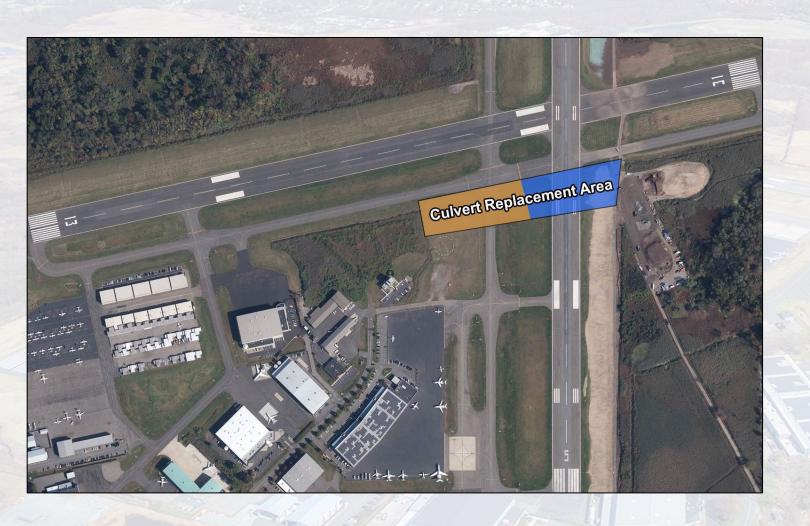
Phase IX Completed September 2023

- ★ Phase IX Summary:
- ★ Drainage Culvert Installation:
 - ★ Replaced existing drainage culvert underneath RWY 5-23 and Taxiway A
 - ★ Installed 72-inch concrete box culvert
 - ♣ RWY 5-23 closed for 27 days

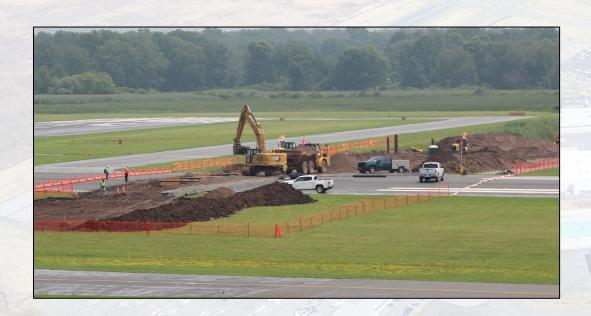
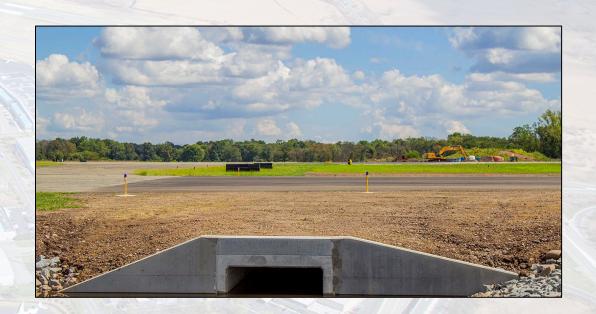
As part of the original development of MMU, a 36-inch drainage pipe was installed in order to allow water flow underneath Runway 5-23. There were no records to indicate the pipe was ever replaced/upgraded

Phase IX addressed this issue, improving water drainage across the airfield and strengthening the runway foundation in anticipation of a newly paved surface within the overall Runway 5-23 Rehabilitation Project
